<b>C-O-N-F-I-D-E-N-T-I-A-L</b>		<b>SEE BOTTOM OF PAGE FOR SPECIAL CONTROLS, IF ANY</b>	
<b>INFORMATION REPORT</b>		This material contains information affecting the National Defense of the United States within the meaning of the Espionage Laws, Title 18, U.S.C. Secs. 793 and 794, the transmission or revelation	
PREPARED AND DISSEMINATED BY <b>CENTRAL INTELLIGENCE AGENCY</b>			
COUNTRY <b>Poland</b>			
SUBJECT <b>Port Information; Gdynia</b>			
NAVY review completed.		DATE DISTRIBUTED <b>17 APR 56</b>	25X1
		NO. OF PAGES <b>5</b>	NO. OF ENCLS.
		SUPPLEMENT TO REPORT #

THE OFFICE OF NAVAL INTELLIGENCE FURNISHED THE FOLLOWING INFORMATION TO CIA FOR IAC DISSEMINATION IN ACCORDANCE WITH PARAGRAPH 3 c OF NSCID #7 (DIO, 8ND No 66-56).

**WORK ASSOCIATED WITH GERMAN  
INDIAN QUAY  
Gdynia, Poland**

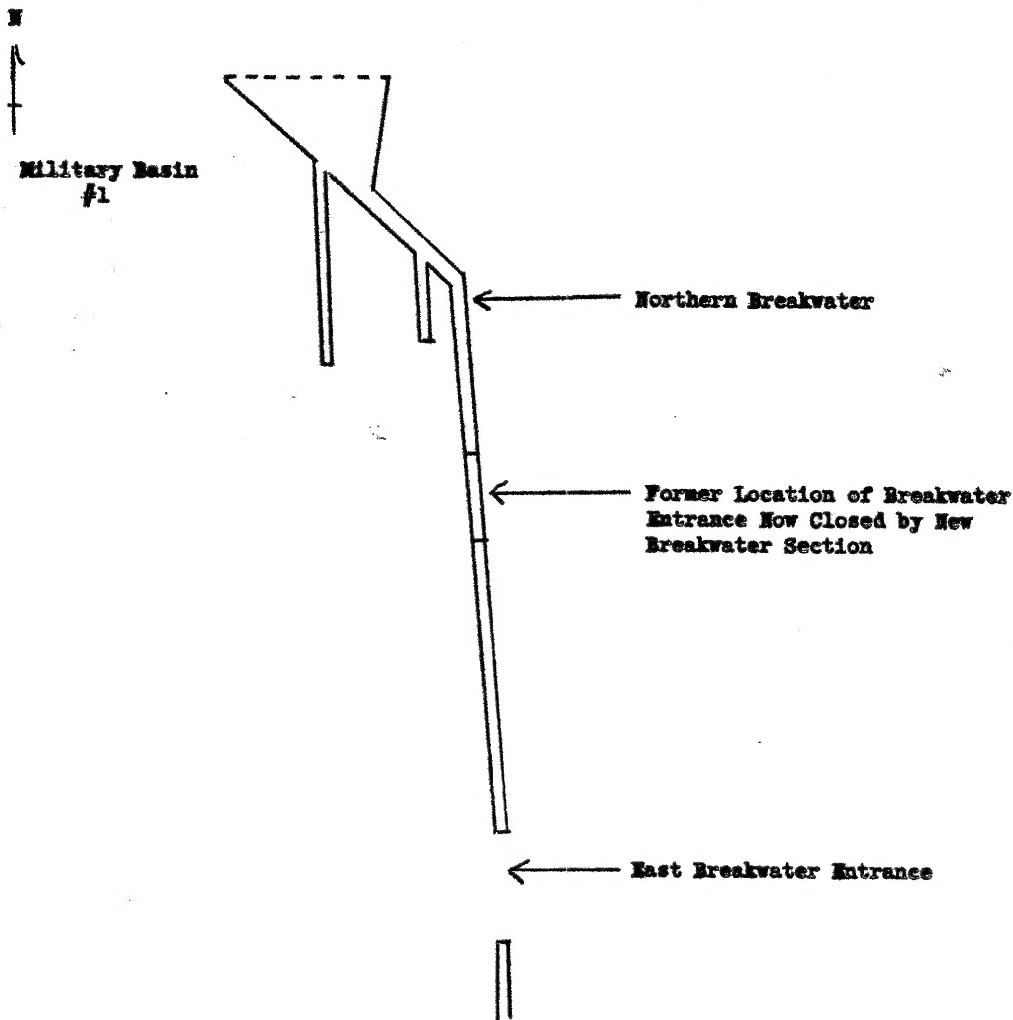
9. [ ] 25X1
10. Area Between Northern Breakwater and Military Basin No 1 [ ] breakwater entrance shown on NO Chart No 4928 at designator G is closed. Sketch of the area between the Northern Breakwater and Military Basin No 1 follows: 25X1
